Manhole Inspection Summary

Manhole # S490__006MH

Location Address: **lighthouse point**

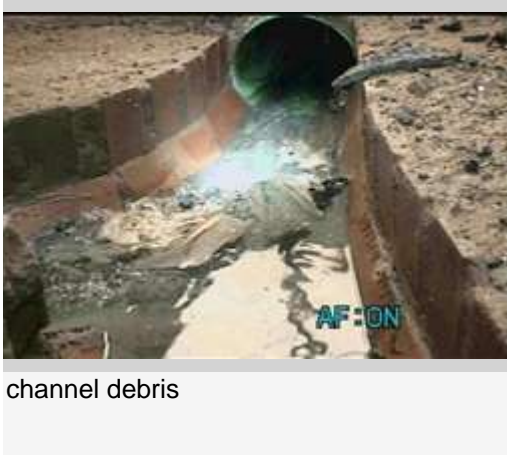
Defect 2

Condition: ☐ Sound ☐ Cracked ☐ Root Intrusion ☐ Deteriorated ☐ Leaks ☒ **Debris**

channel debris

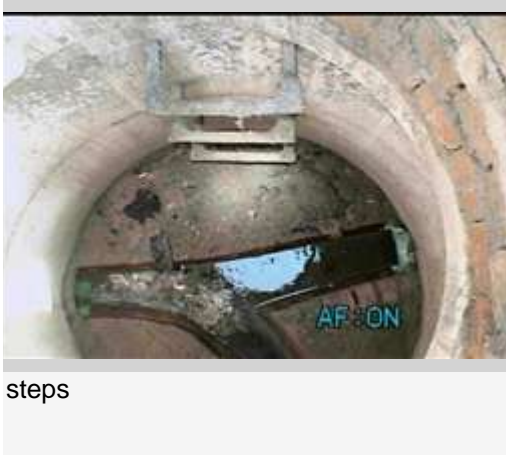
Defect 1

Count: **3** Missing: **0** ☒ **Corroded**

steps

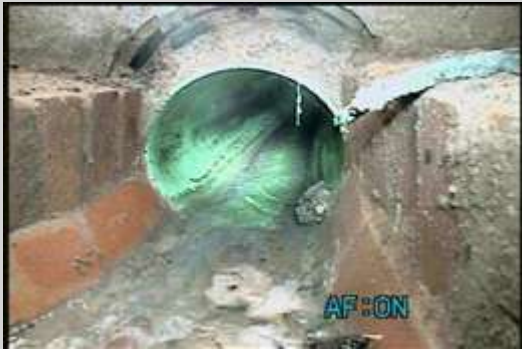
12 O'Clock Outflow

10 in. Circular Gravity Sewer
Pipe Out @ 12 O'Clock

Deposits: ☒ None ☐ Mud ☐ Sludge ☐ Debris ☐ Grease

Infiltration: **None** Pipe Seal Cond: **Unknown**

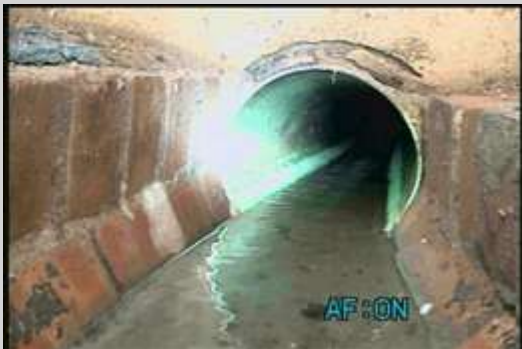
6 O'Clock Inflow

8 in. Circular Gravity Sewer
Pipe In @ 6 O'Clock

Deposits: ☒ None ☐ Mud ☐ Sludge ☐ Debris ☐ Grease

Infiltration: **None** Pipe Seal Cond: **Unknown**

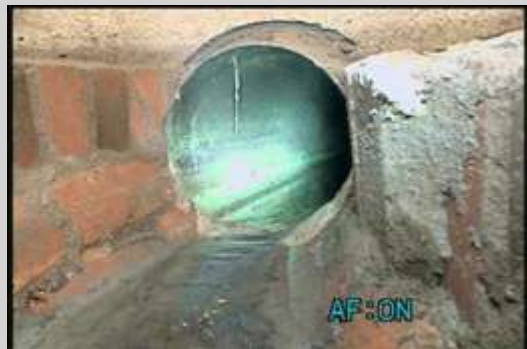
9 O'Clock Inflow

8 in. Circular Gravity Sewer

Pipe In @ 9 O'Clock

Deposits: ☒ None ☐ Mud ☐ Sludge ☐ Debris ☐ Grease

Infiltration: **None** Pipe Seal Cond: **Unknown**
